Manhole Inspection Summary

Manhole # S35W__016MH

Inspection ☐ Is Incomplete Rating: **3) Fair**

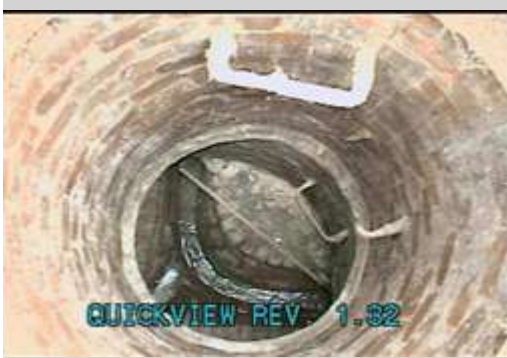
Defect 1

Steps Count: **4** Missing: **2** ☒ **Corroded**

missing steps

corroded/missing steps

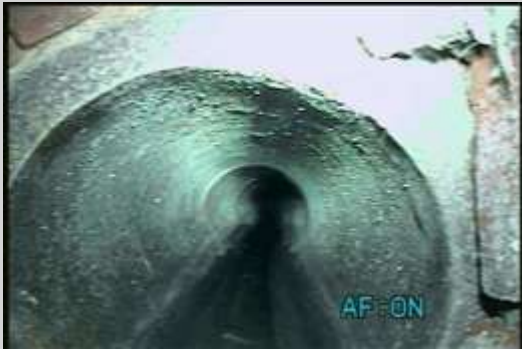
12 O'Clock Outflow

6 in. Circular Gravity Sewer
Pipe Out @ 12 O'Clock

Infiltration: **Evidence** Pipe Seal Cond: **Unknown**

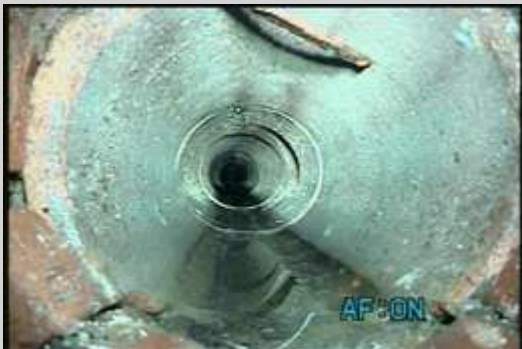
3 O'Clock Inflow

8 in. Circular Gravity Sewer
Pipe In @ 3 O'Clock

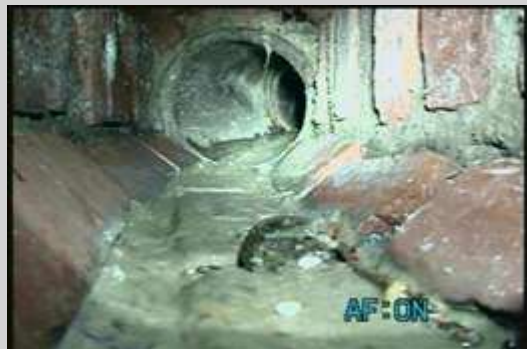
7 O'Clock Inflow

6 in. Circular Gravity Sewer
Pipe In @ 7 O'Clock
